PHOTOGRAPHS

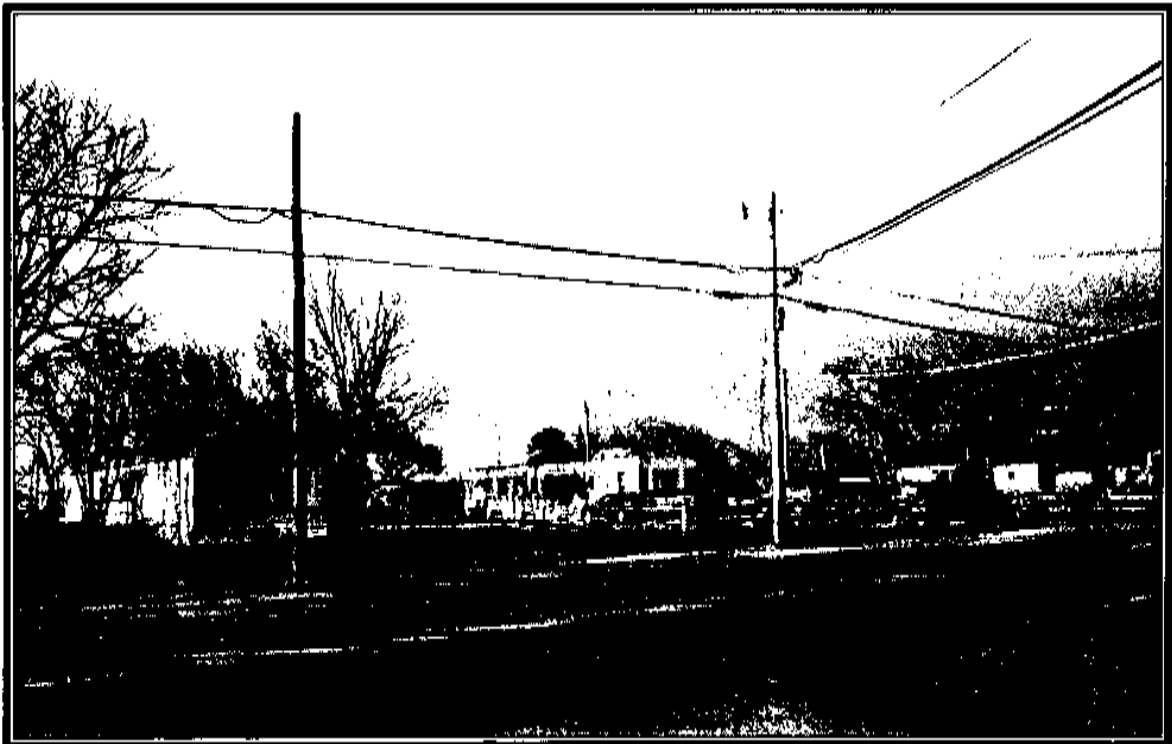
Photograph 26. S-8393, Belltown Historic District, view of the trailers that replaced contributing resources on the south side of U.S. Route 9, facing southwest.

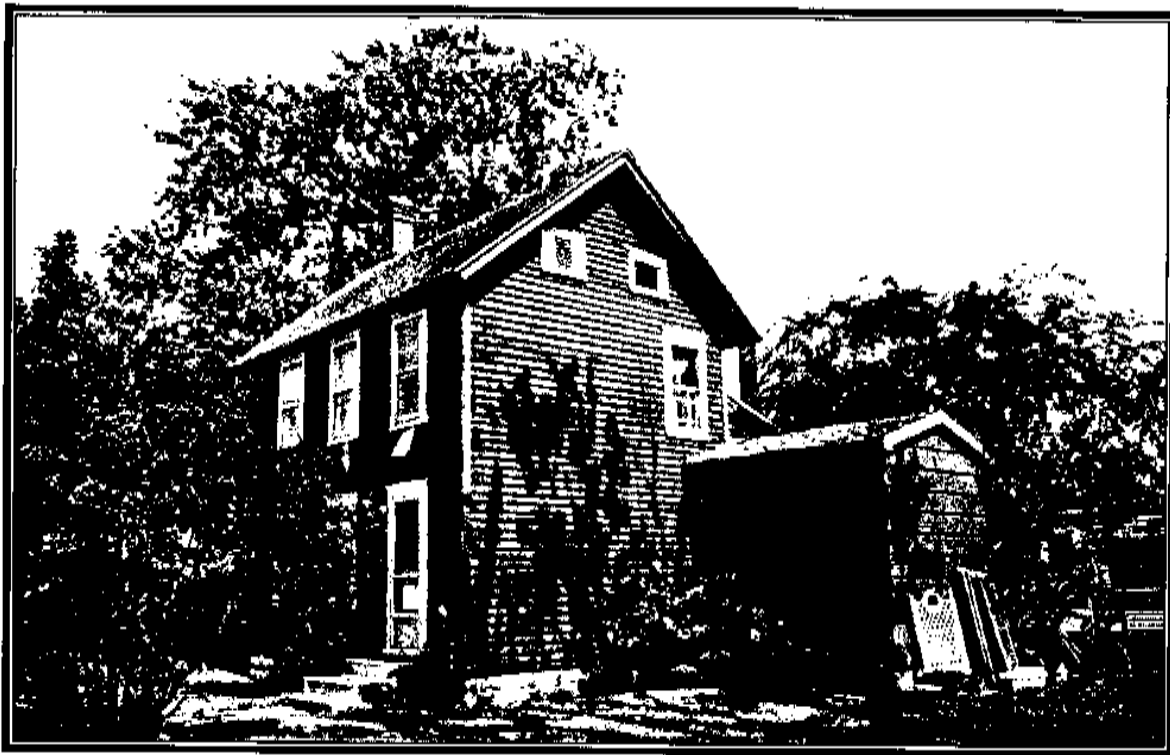
Photograph 27. S-8393, Belltown Historic District, house on lot 3-34-5-214, facing east. Evaluated as contributing in 1989, the house has not changed. It is shown as Plate 33 in the Tidlow et al. 1990 report.

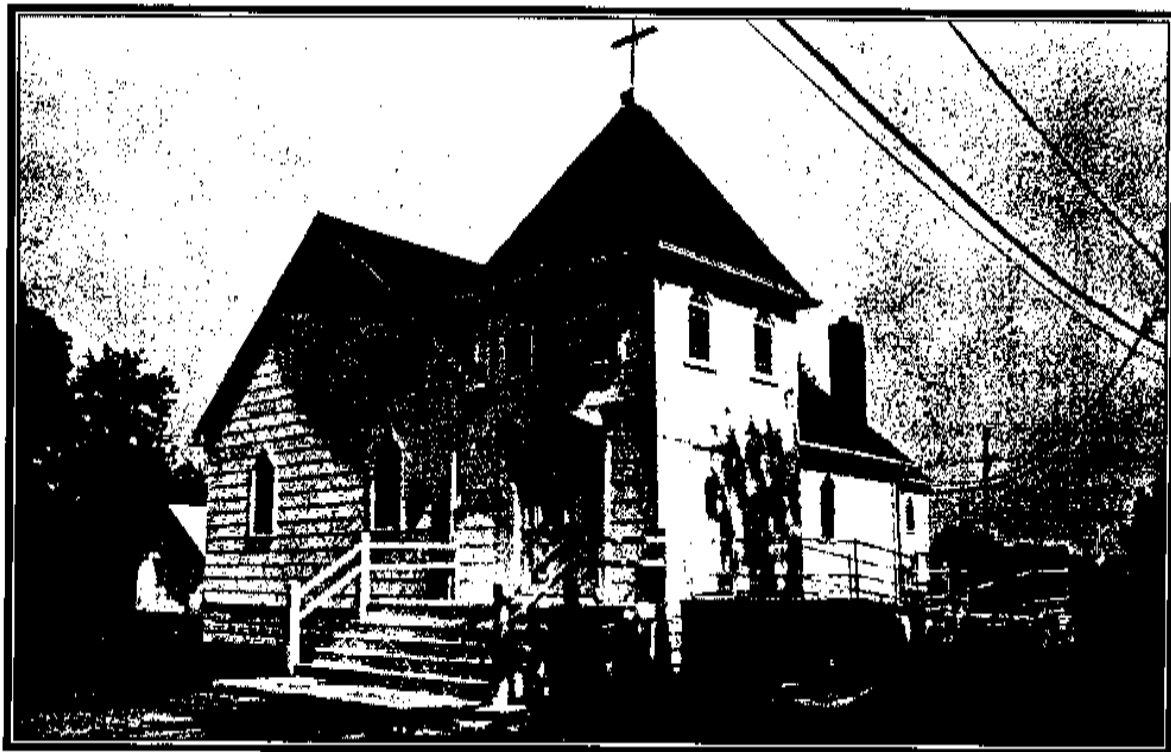
Photograph 28. S-8398, Belltown Historic District, John Wesley Methodist Episcopal Church, facing southeast. The building is a contributing resource and also individually eligible for NRHP listing.

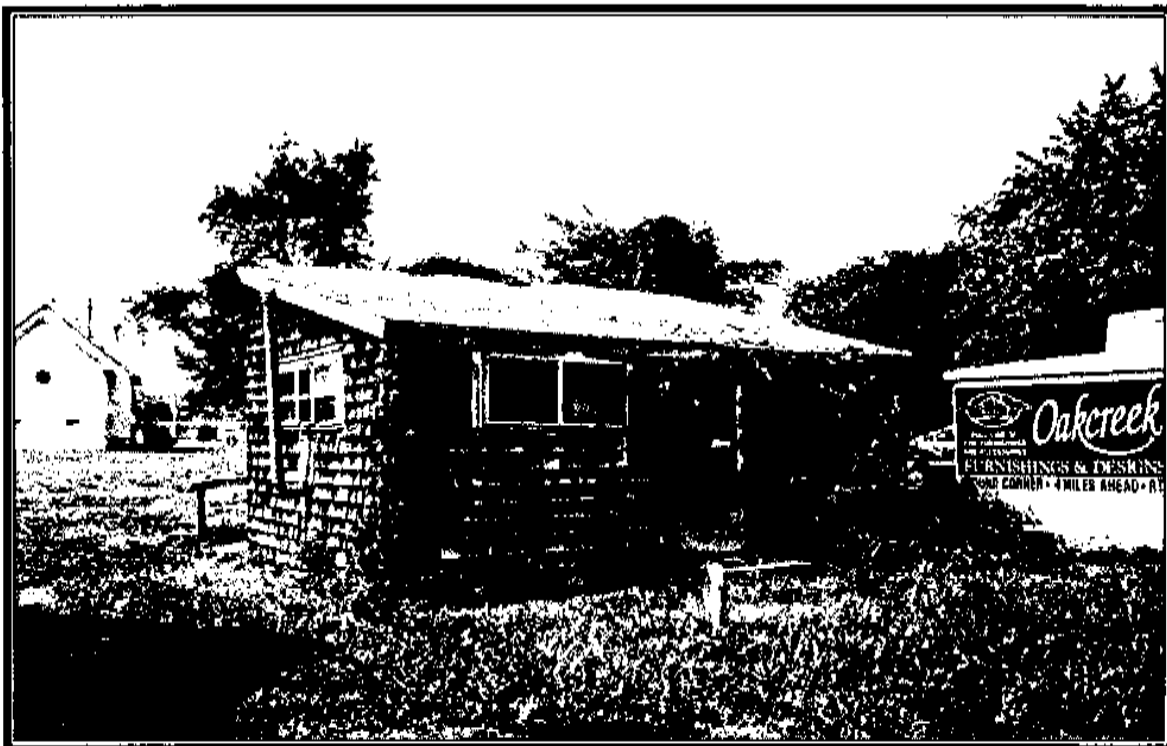
Photograph 29. S-8393, Belltown Historic District, house on the Beaver Dam Road portion of lot 3-34-5-216, facing north. Evaluated as contributing in 1989, the house has not changed. It is shown as Plate 36 in the Tidlow et al. 1990 report.

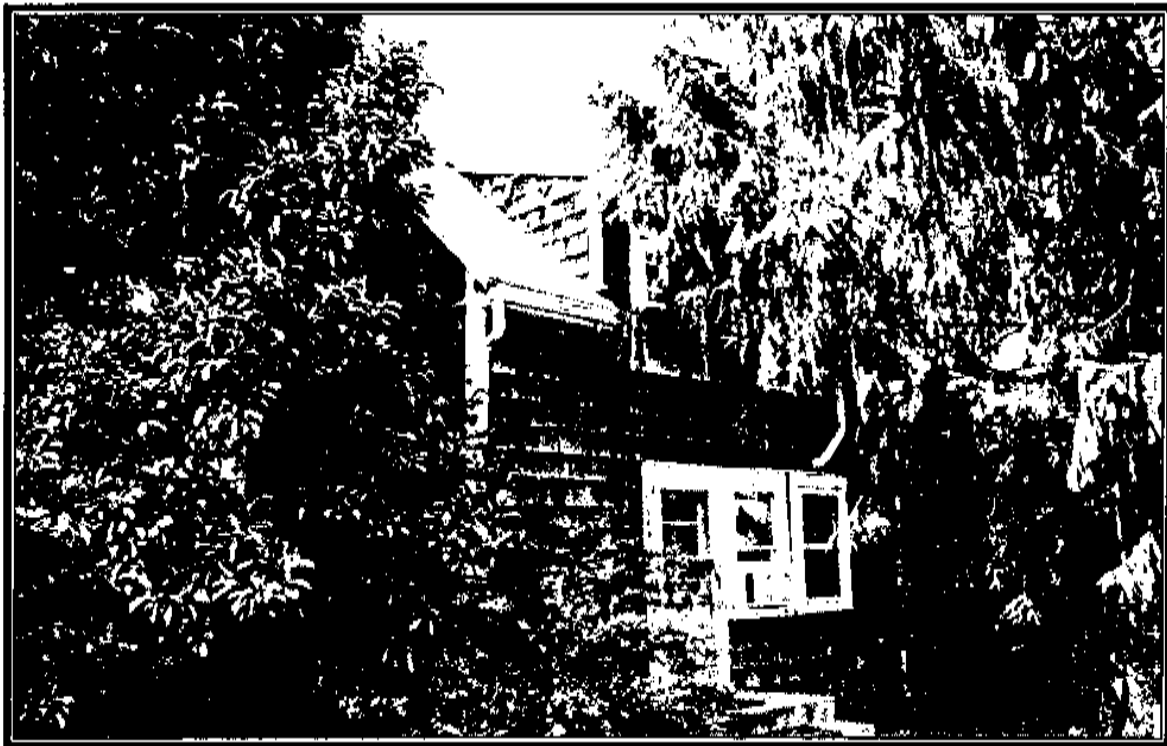
Photograph 30. S-8393, Belltown Historic District, second house on the Beaver Dam Road portion of lot 3-34-5-216, facing north. Evaluated as contributing in 1989, the house has not changed. It is shown as Plate 35 in the Tidlow et al. 1990 report.

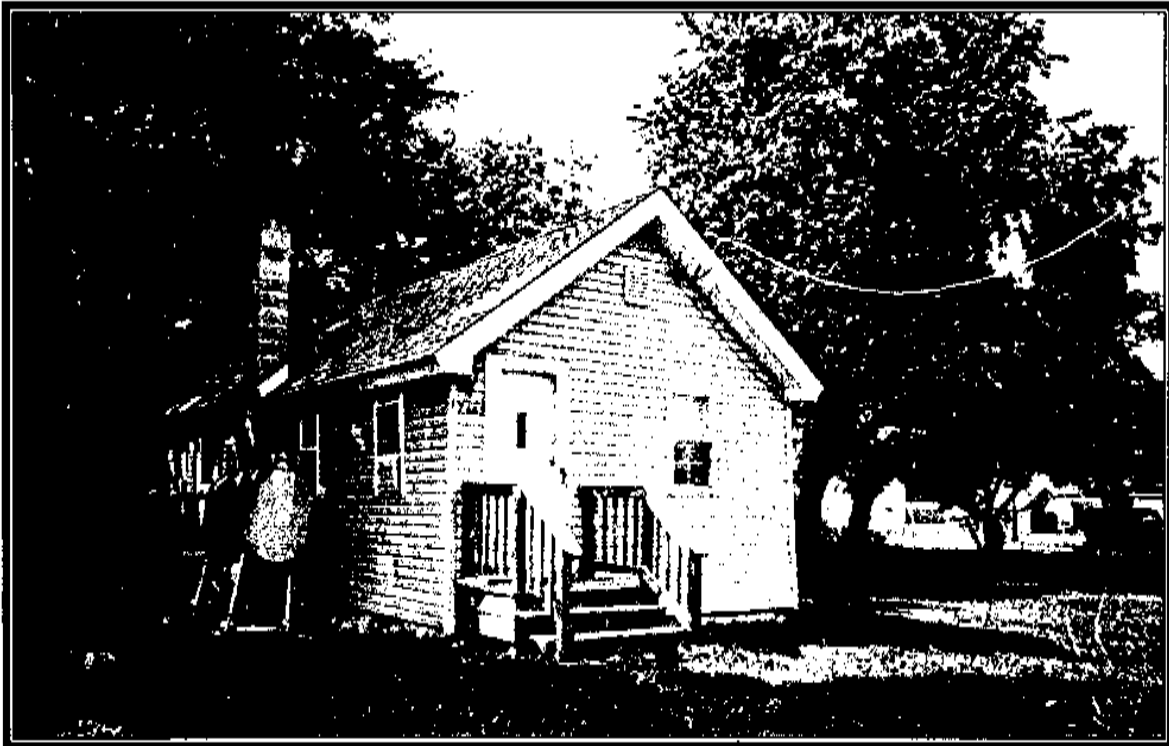
Photograph 31. S-8393, Belltown Historic District, house on lot 3-34-5-212, facing north. It corresponds to Plate 32 in the Tidlow et al. 1990 report. It is now evaluated as noncontributing due to alterations, including siding, replacement fenestration, and a new roof.

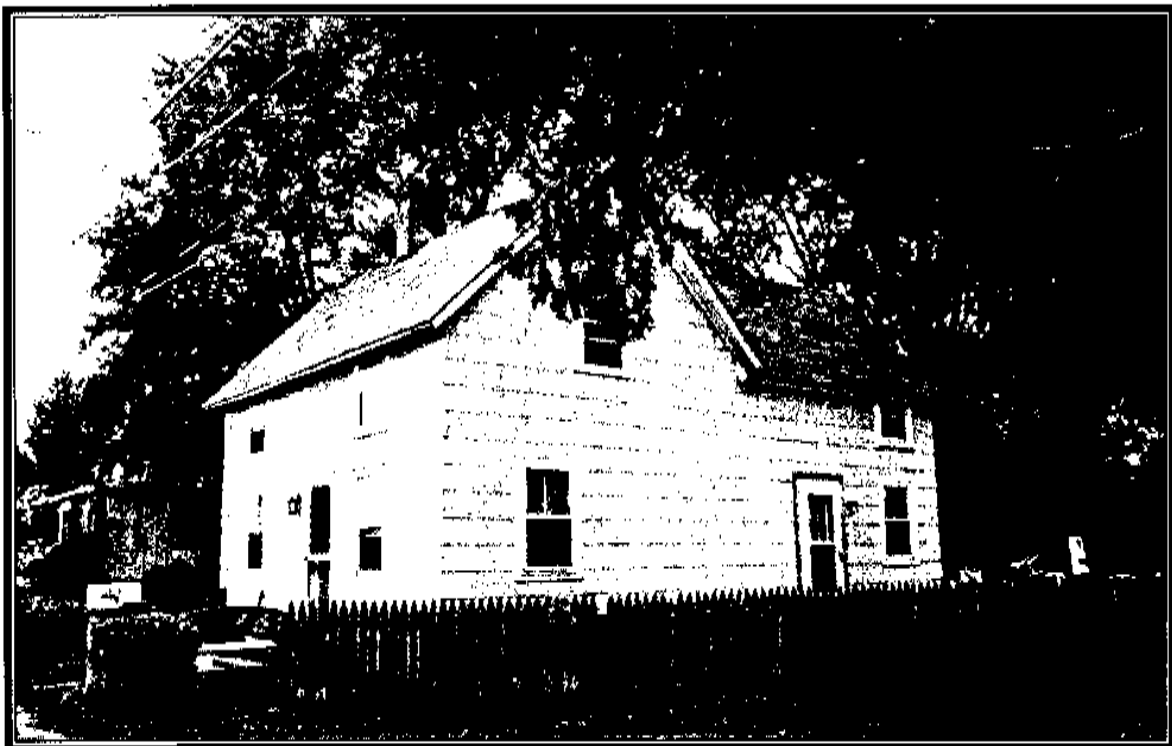
Photograph 33. S-8393, Belltown Historic District, house on lot 3-34-5-210, facing west. Evaluated as contributing in 1989, the house has not changed. It is shown as Plate 30 in the Tidlow et al. report.

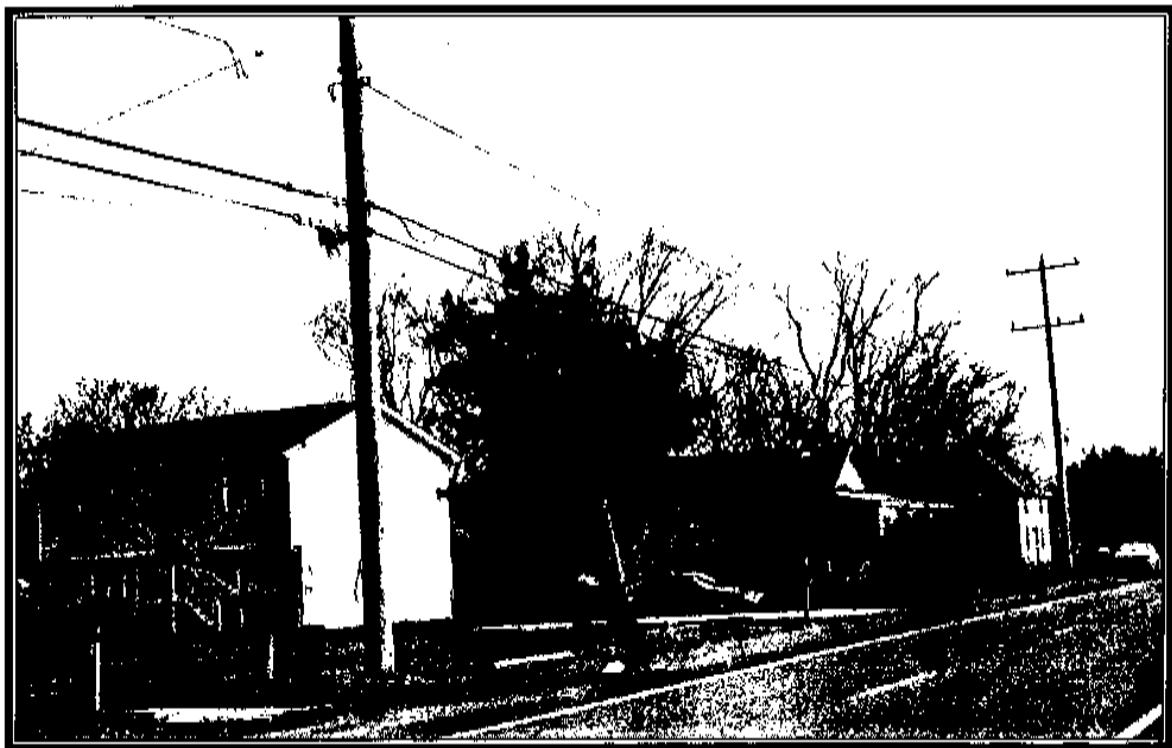
Photograph 34. S-8393, Belltown Historic District, showing a contributing house on lot 3-34-5-207 (middle house) and a noncontributing one on lot 3-34-5-206 (formerly a vacant lot), facing northeast.

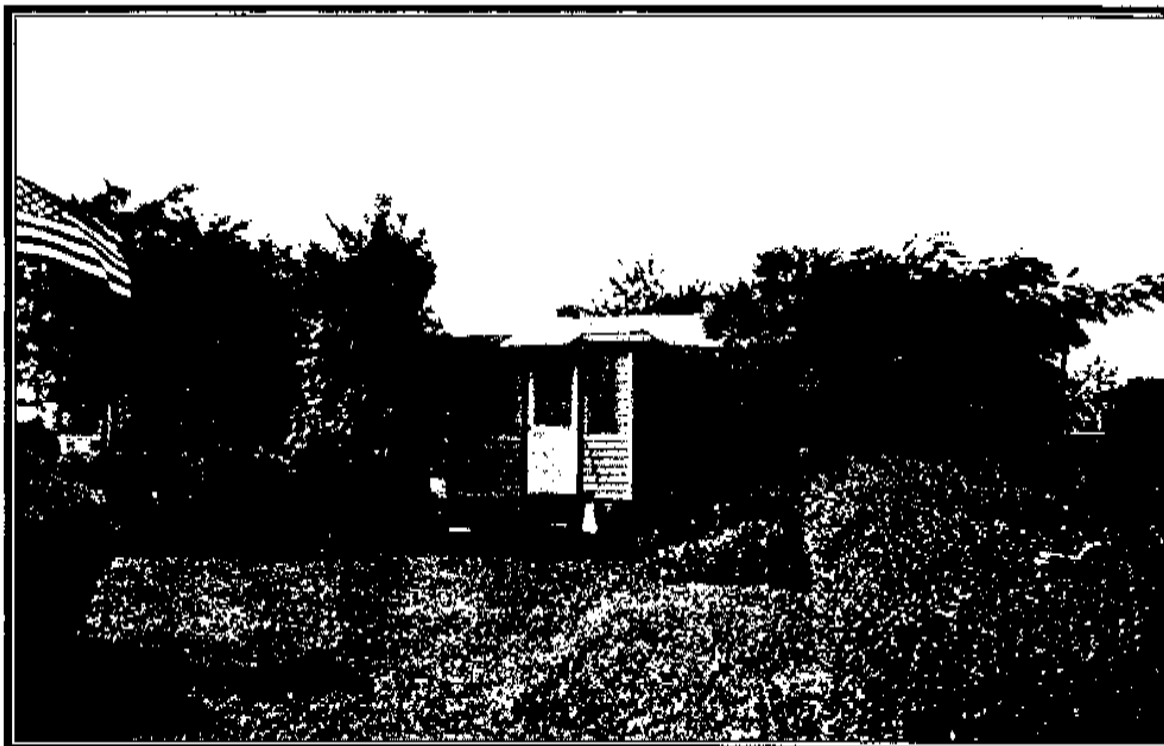
Photograph 35. S-8393, Belltown Historic District, noncontributing house on lot 3-34-5-200, facing northwest.

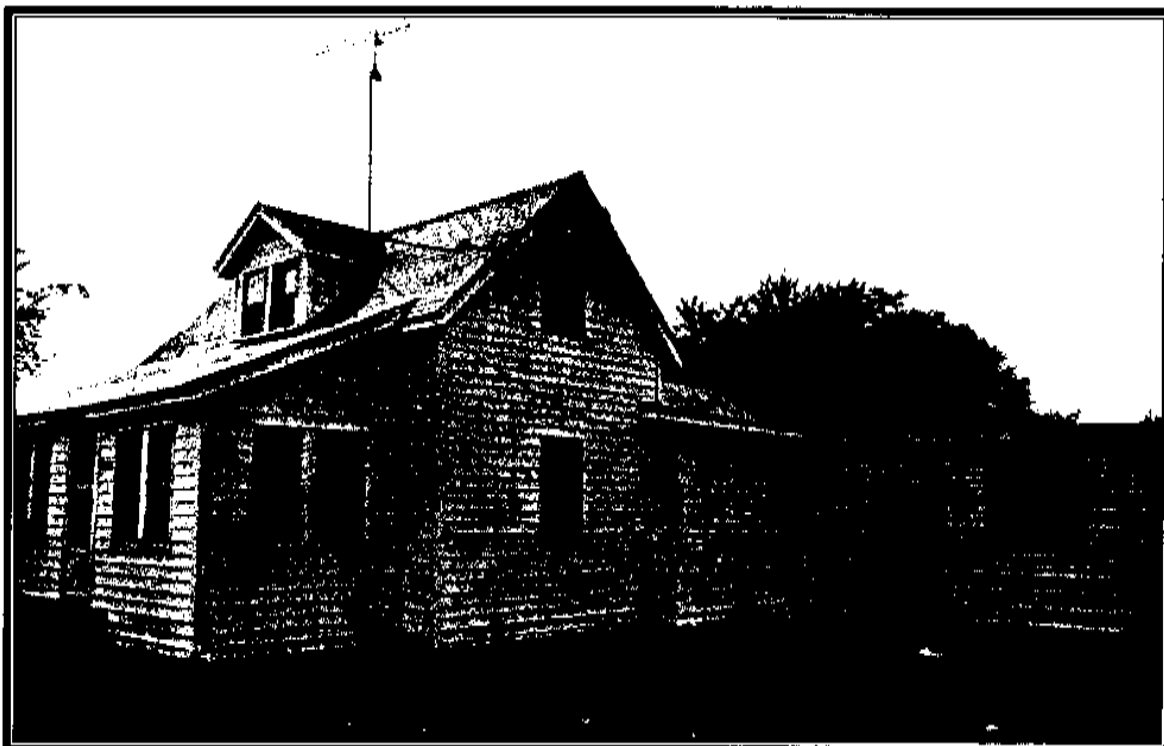
Photograph 36. S-8393, Belltown Historic District, house on lot 3-34-5-198, facing west. It was originally evaluated as contributing, despite the one-story addition on the east side. It is shown as Plate 25 in the Tidlow et al. 1990 report.

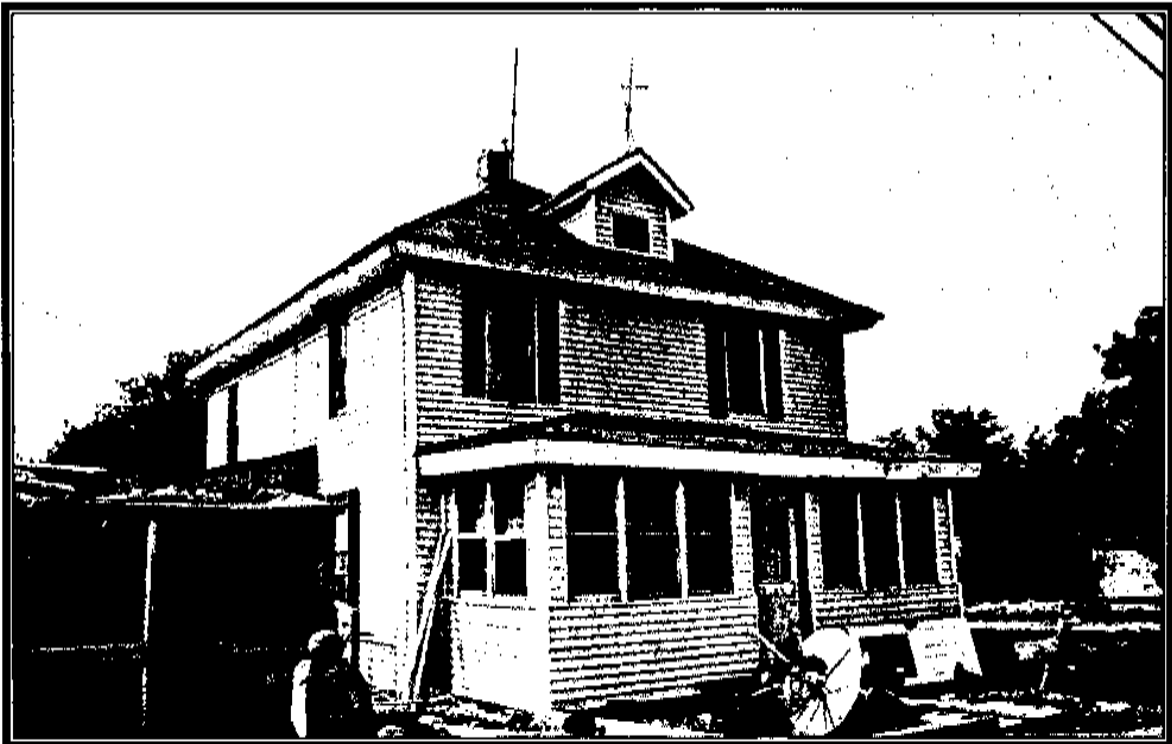
Photograph 37. S-8393, Belltown Historic District, contributing house on lot 3-34-5-196, facing north. It is shown as Plate 23 in the Tidlow et al. 1990 report. Despite new siding and a roof, the house has not changed substantially.

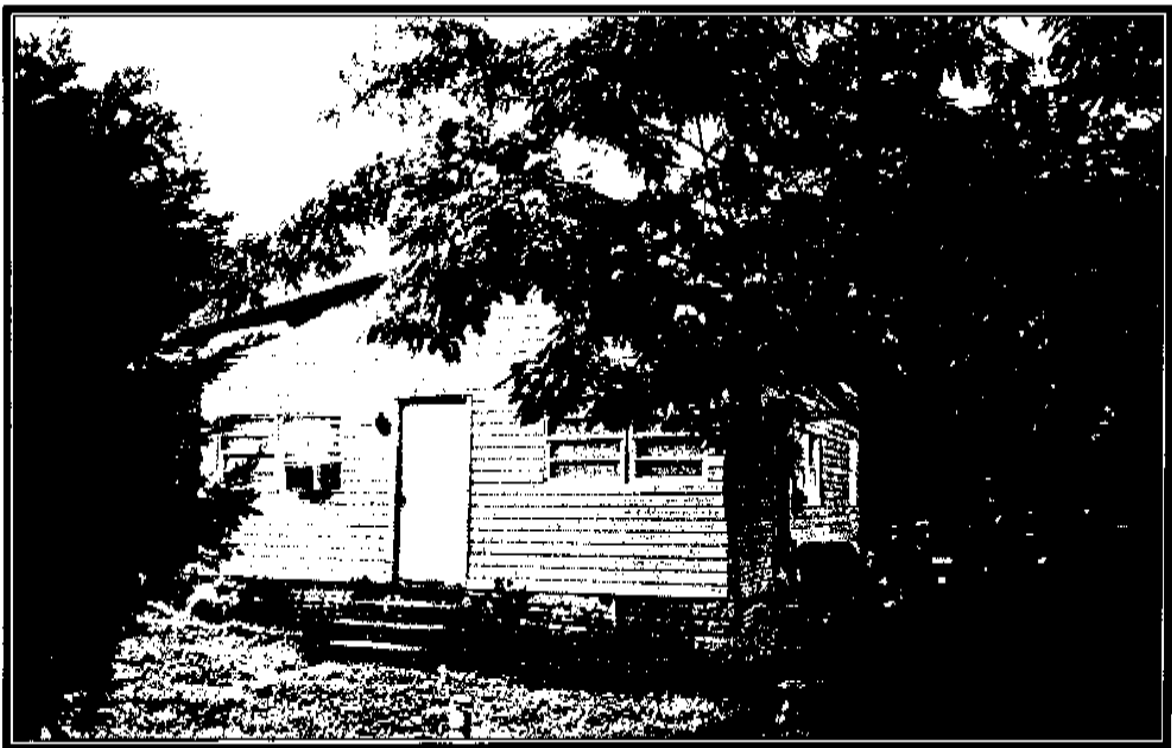
Photograph 38. S-8393, Belltown Historic District, noncontributing trailer on lots 3-34-5-190 and 3-34-5-191, facing west.

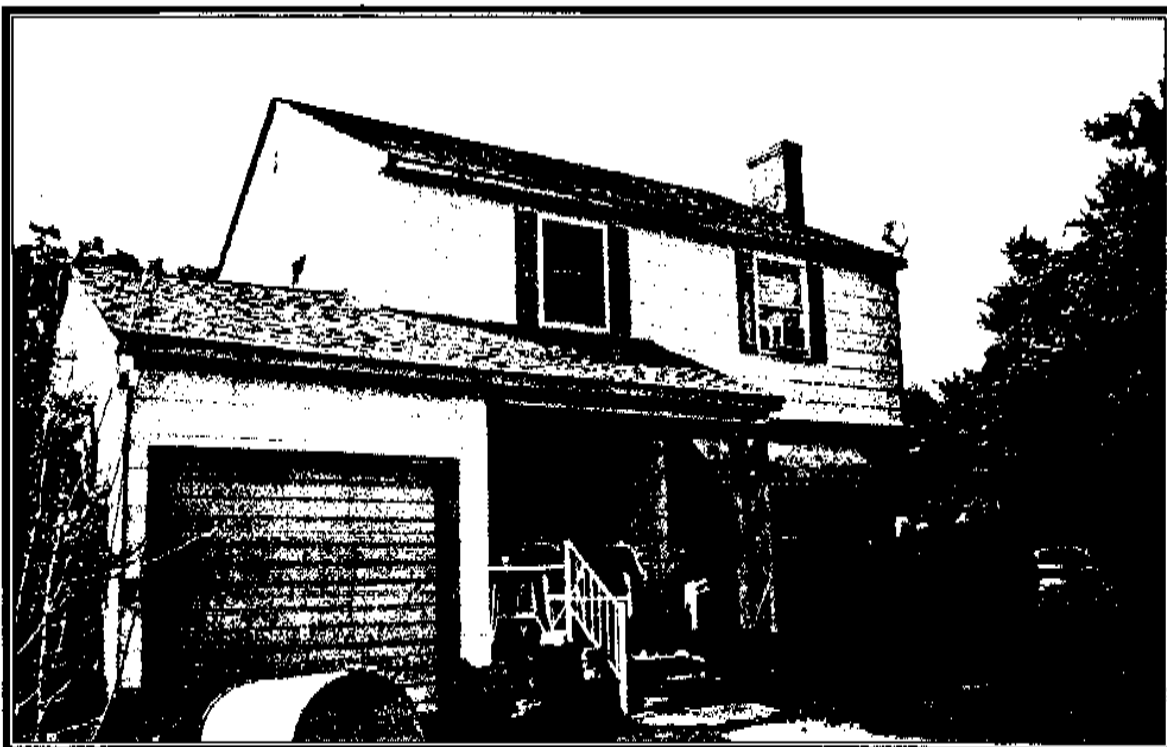
Photograph 39. S-8393, Belltown Historic District, house on lot 3-34-5-190, facing north. It is shown as Plate 20 in the Tidlow et al. report, and was originally evaluated as a contributing resource despite the one-story garage addition and a second addition on the east side.

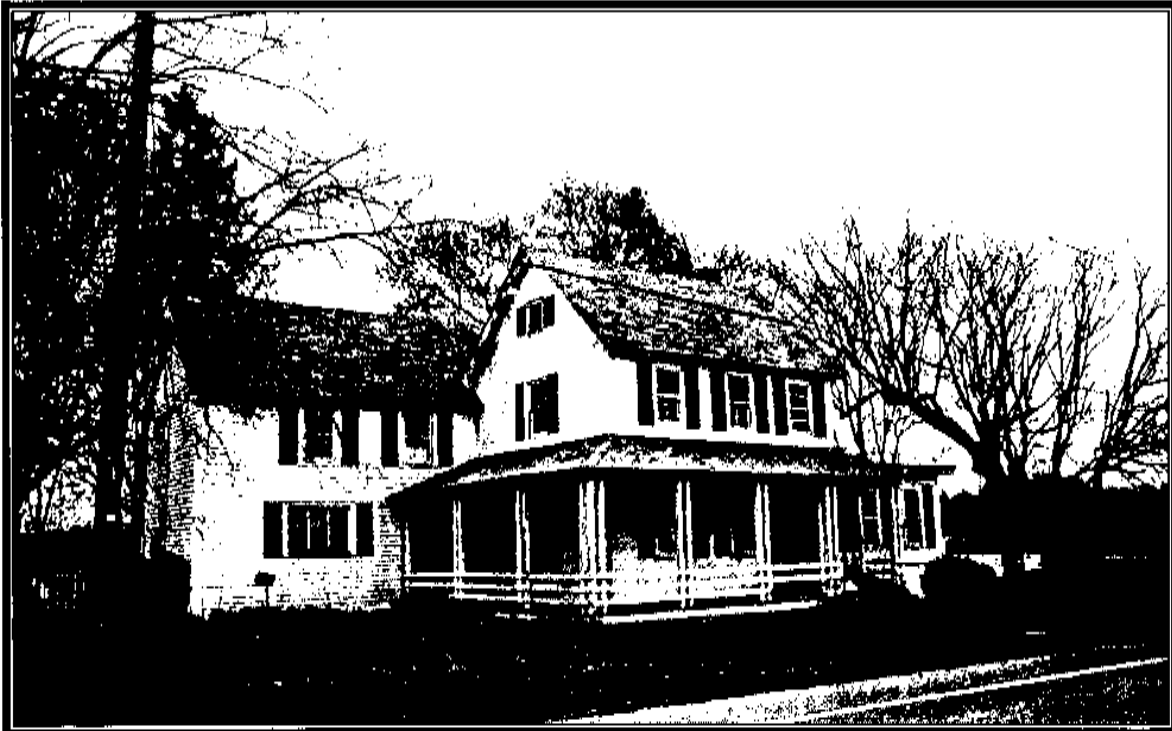
Photograph 40. S-8393, Belltown Historic District, house on lot 3-34-5-189, facing northwest. It is shown as Plate 19 in the Tidlow et al. 1990 report. The house has deteriorated markedly since that report was prepared, and the cross-gable jerkinhead roof has been replaced.

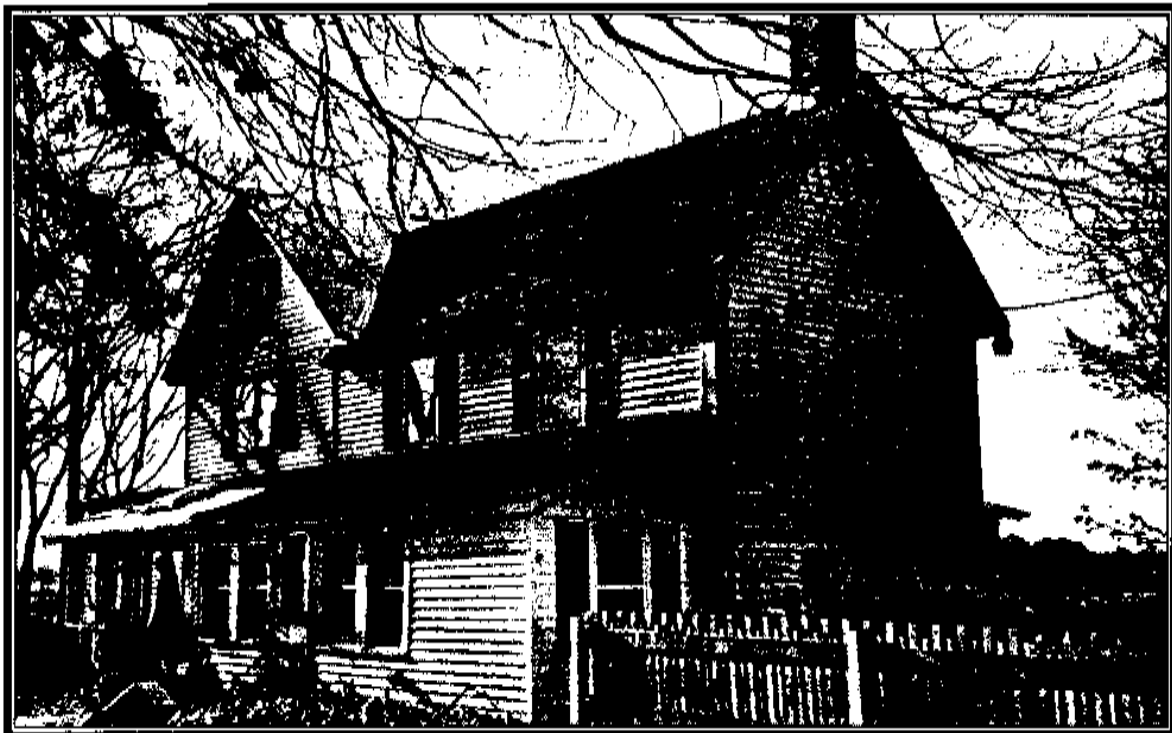
Photograph 42. S-900, Oakney Farmhouse, east side and rear of the house, facing west. The two-story horizontal portion is the original portion of the house.

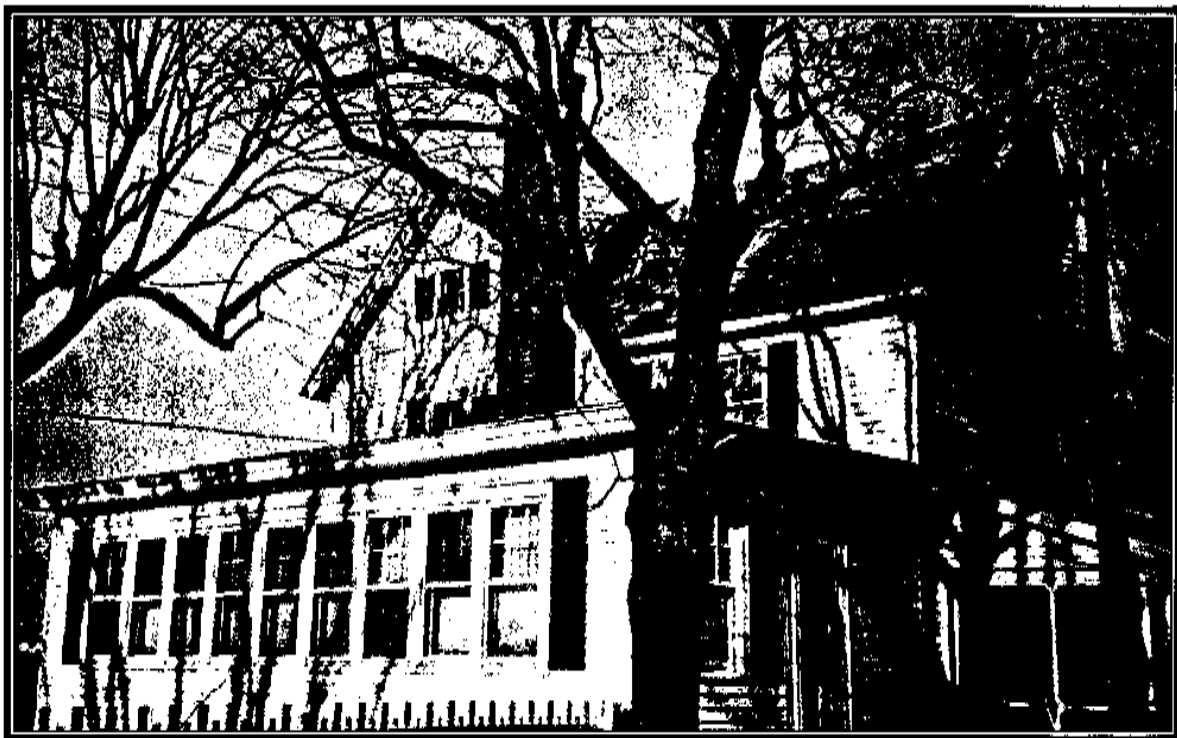
Photograph 43. S-900, Oakney Farmhouse, west side and rear of the house, facing northeast. The two-story rear ell dates from ca. 1919, the one-story portion to 1954.

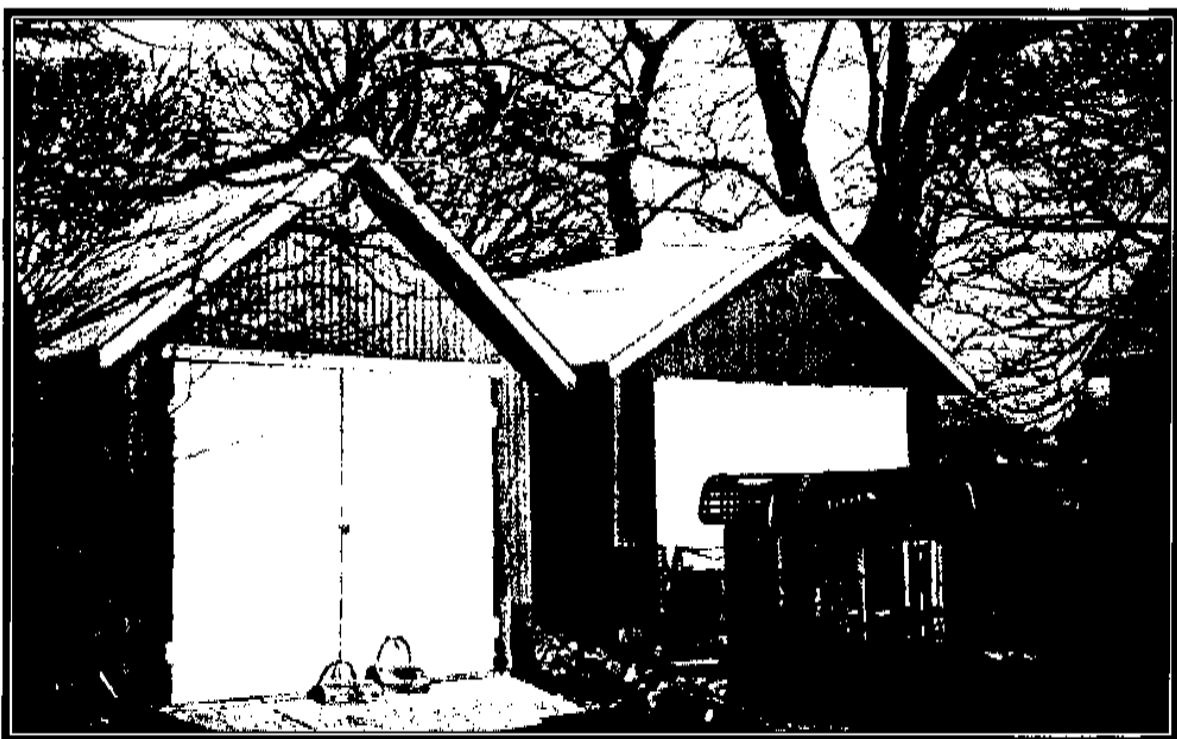
Photograph 44. S-900, Oakney Farmhouse, two nonhistoric garages located on the property, facing northeast.

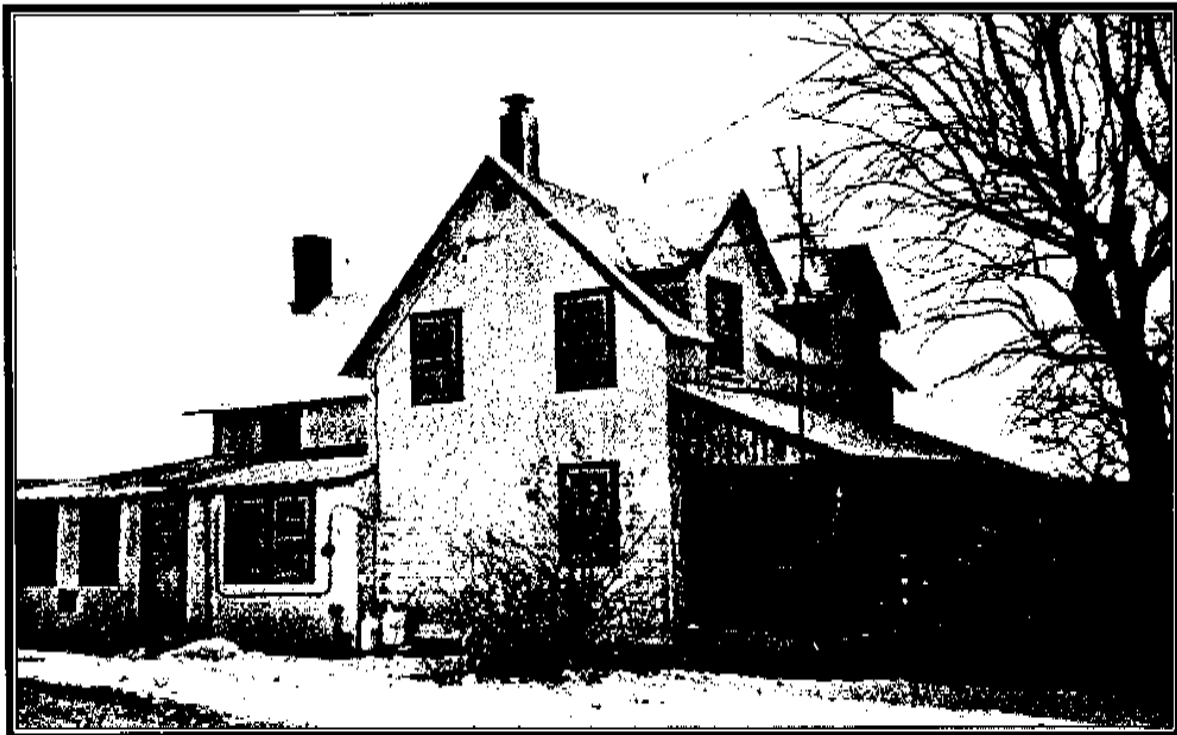
Photograph 45. S-898, Norwood-Jackson Farm, north and front (west) sides of the farmhouse, facing southeast.

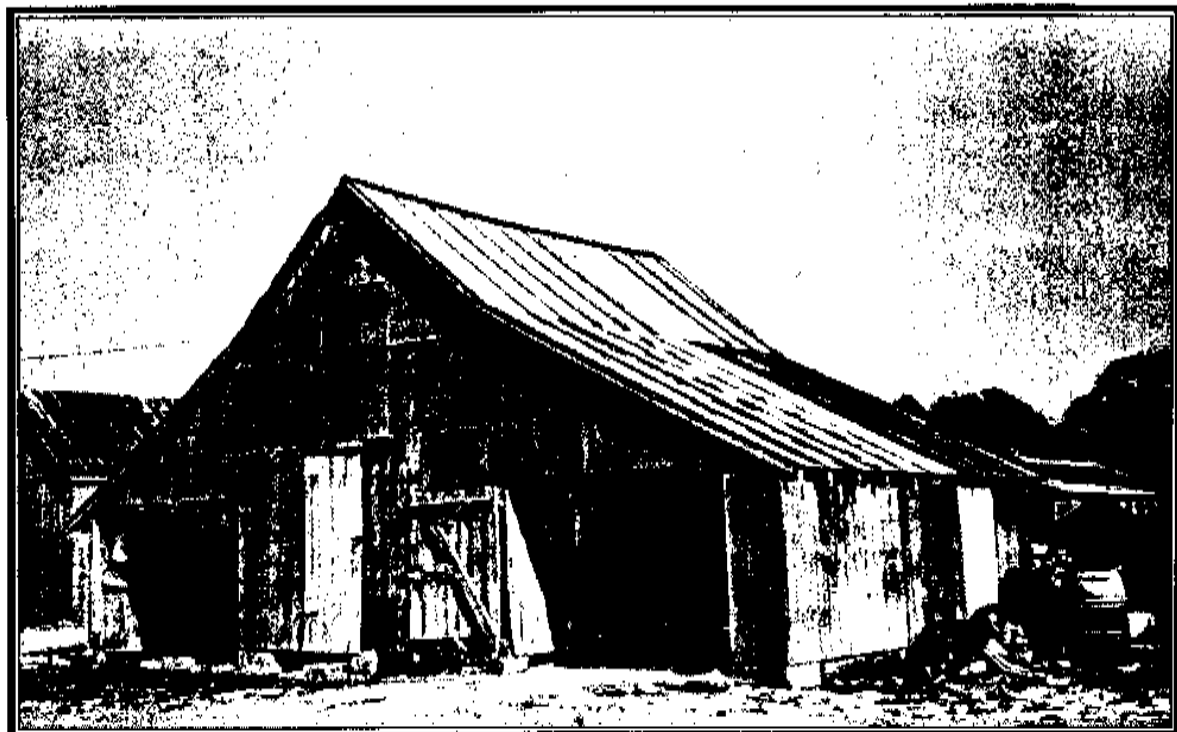
Photograph 46. S-898, Norwood-Jackson Farm, front (south) and east sides of the carriage barn, facing northwest.

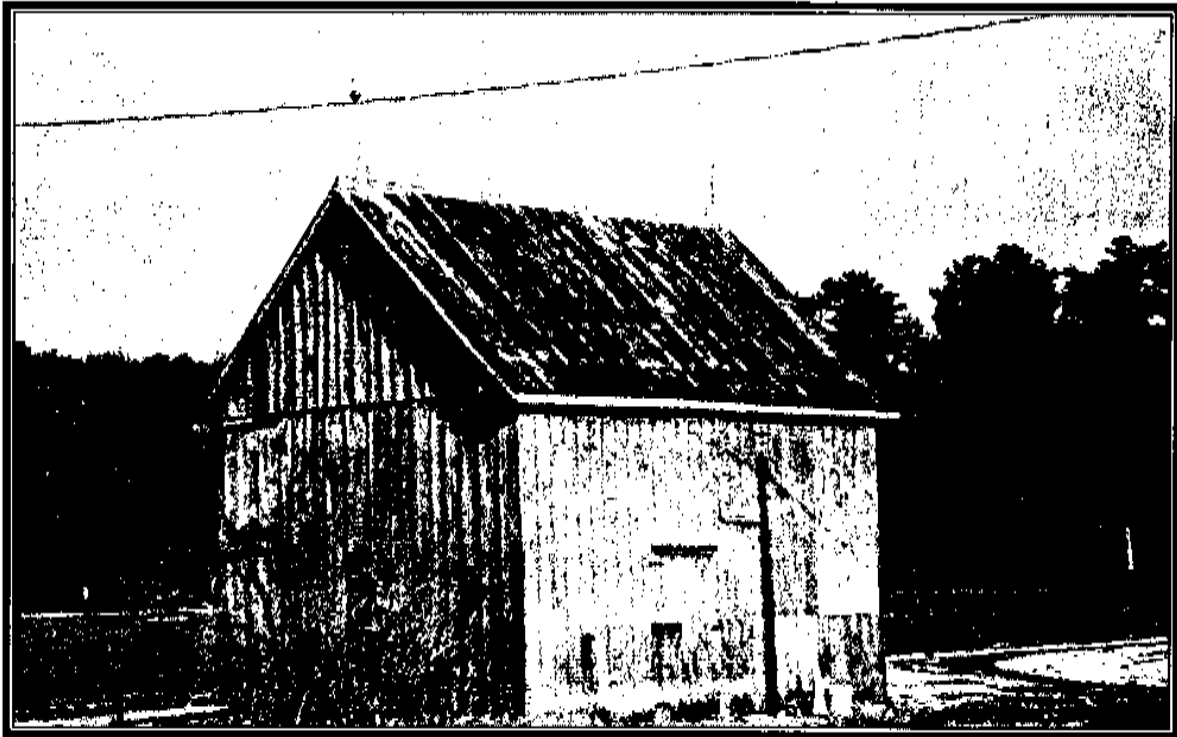
Photograph 47. S-898, Norwood-Jackson Farm, south and rear (east) side of the barn, facing northwest.

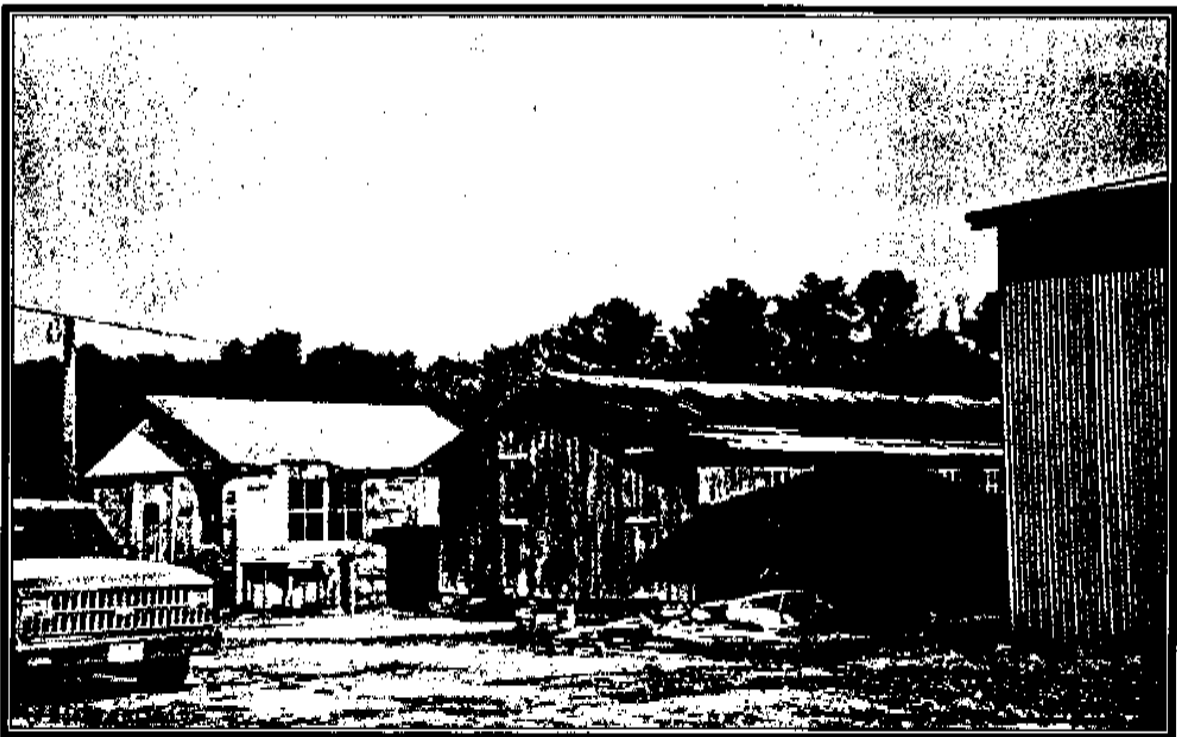
Photograph 48. S-898, Norwood-Jackson Farm, concrete block milkhouse (left), wood frame workshop (center), and the corner of the modern barn, facing northwest.

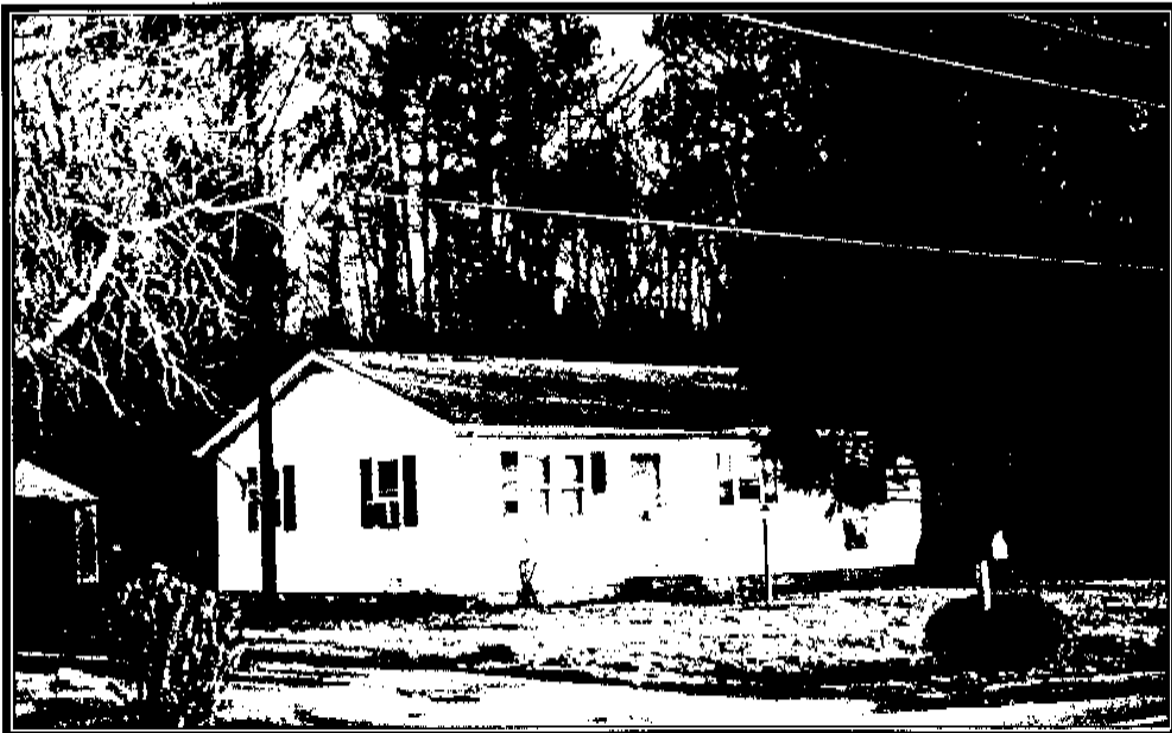
Photograph 49. S-11730, Jimtown, house on Beaver Dam Road south of Jimtown Road, dating stylistically to the mid-1960s, facing southeast.

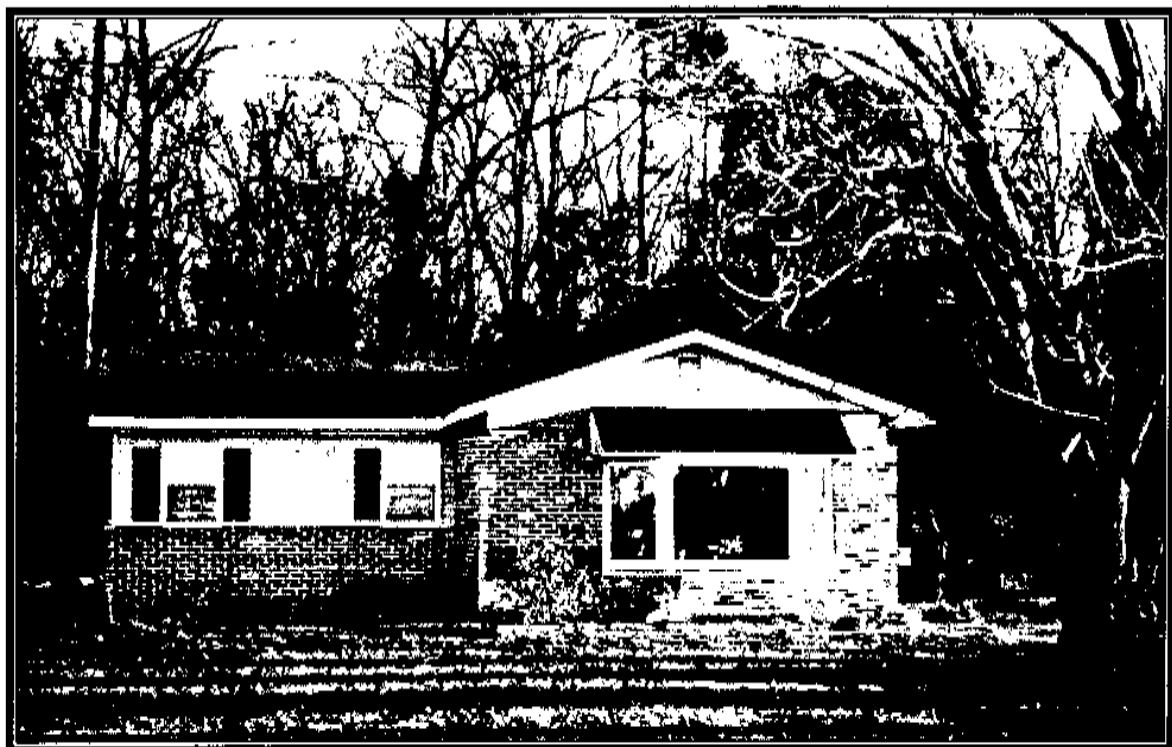
Photograph 50. S-11730, Jimtown, house on Beaver Dam Road south of Jimtown Road, facing southeast. It may have been built prior to 1963, but it has been altered.

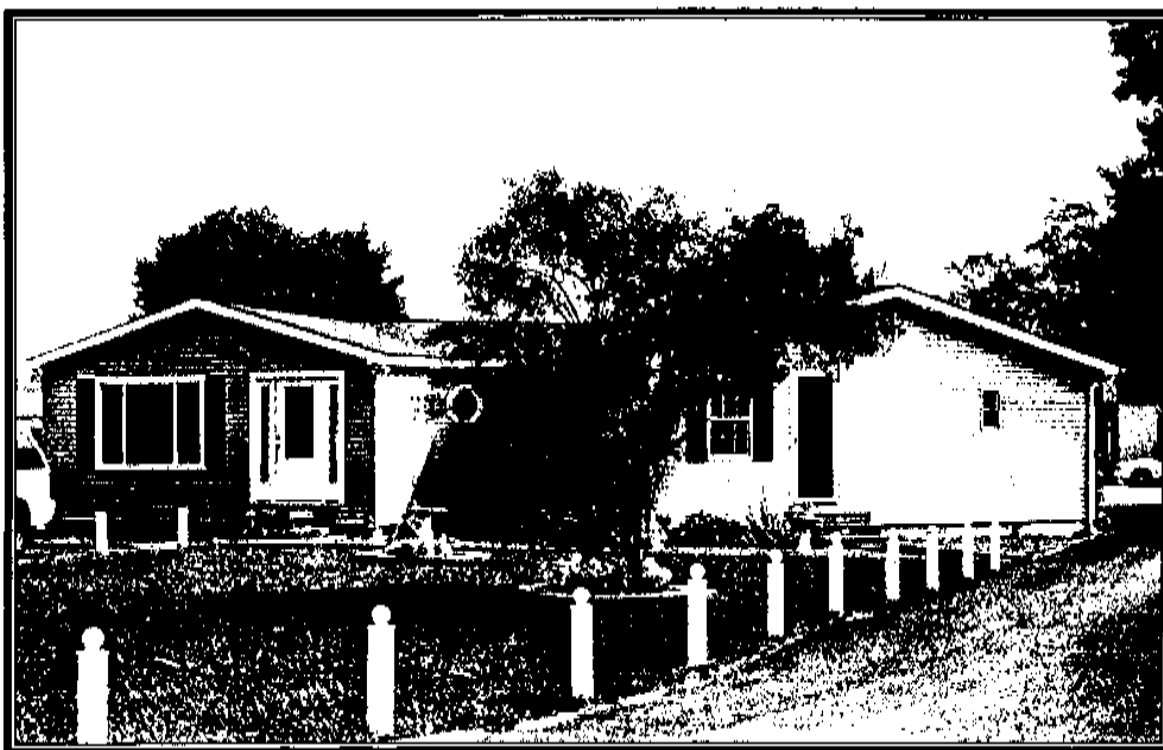
Photograph 57. S-11730, Jimtown, altered mid-twentieth century house on the north side of Jimtown Road, facing northeast. The house has been nearly doubled in size.

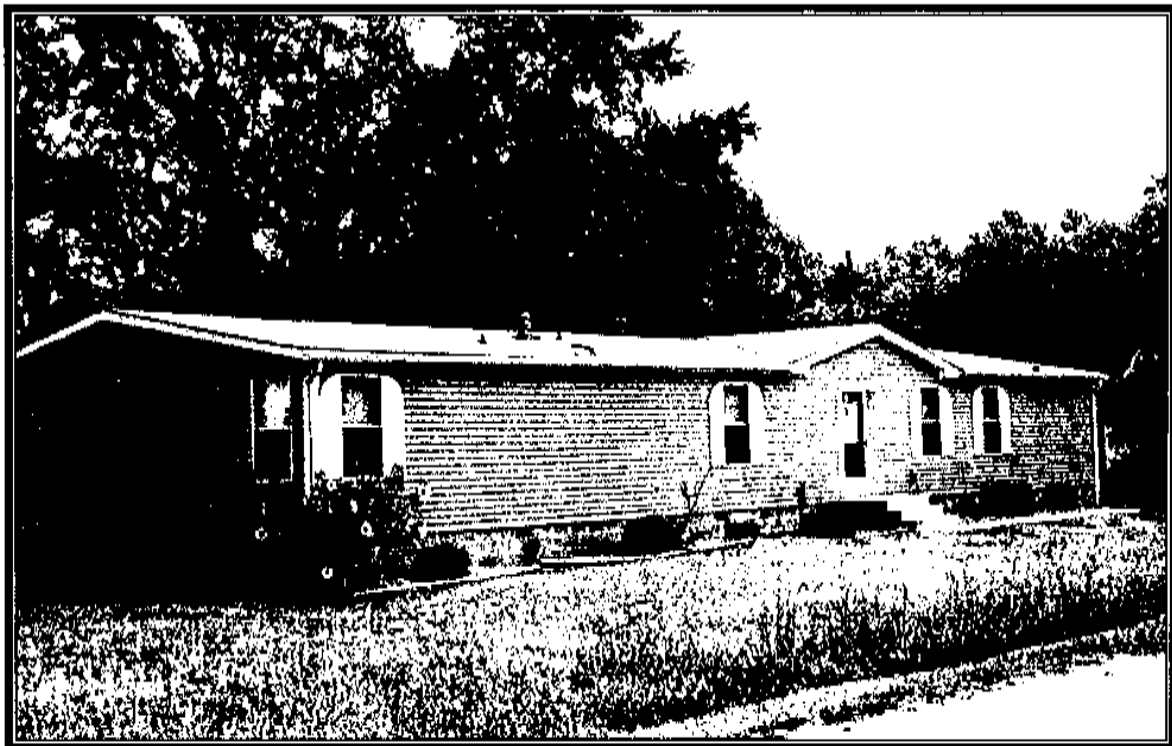
Photograph 68. S-11730, Jimtown, Resource S-941, a house located on the south side of Jimtown Road, facing southwest. The one-story section on the left side of the photograph dates from the late twentieth century.
